FULLER-KINYON PUMP SCREW INSPECTION CRITERIA

The following standards will allow you to inspect your own pump screw before shipping it back to our Manheim, Pennsylvania factory for exchange. If this criteria is carefully followed you can, in most cases, determine the screw's suitability for repair.

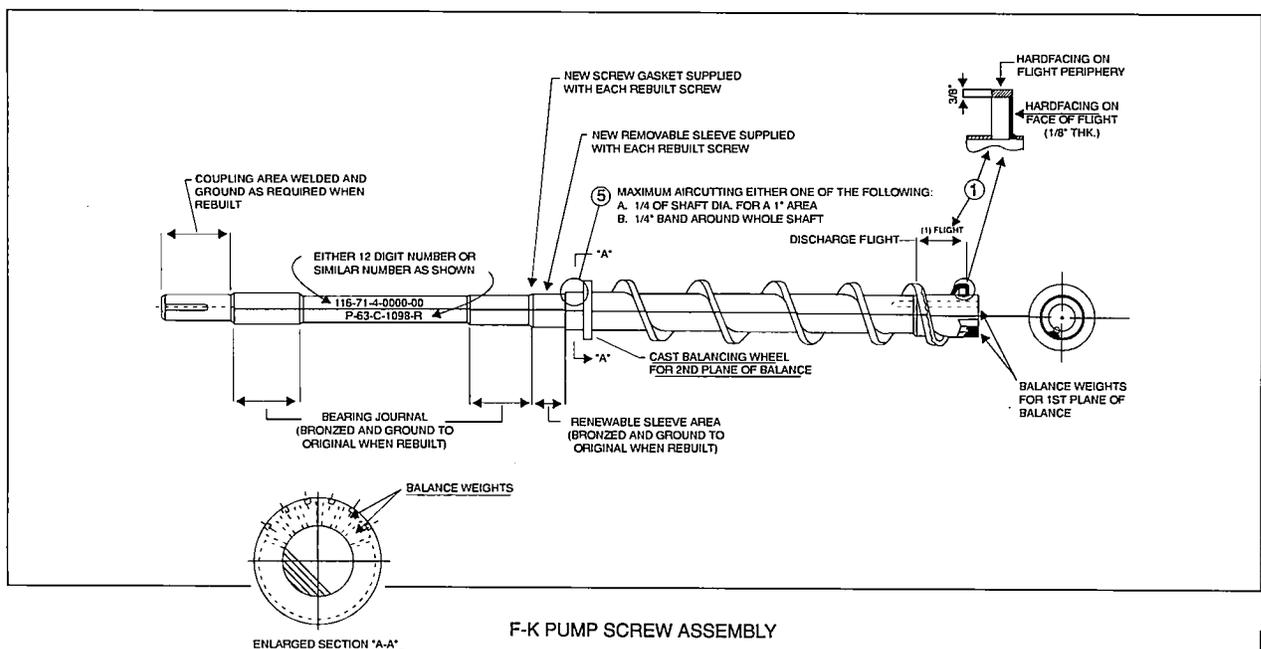
1 - FLIGHT SECTION – If the flight base metal is worn under the hardfacing, either on the flight periphery or face, we replace the flight. The thickness of hardfacing on the periphery is approximately 3/8" thick and about 1/8" thick on the flight face. Flights are replaced in one turn (360°) segments. We list the maximum number of flights per screw size that can economically be replace.

2 - BALANCING HOLES – We can repair any number of balancing holes that are worn through behind the threaded area. If any one of the balancing holes at the end of the screw is air cut so that more than one-quarter of the threaded area is gone (preventing proper installation of an Allen screw), the pump screw cannot be rebuilt properly.

5 - SHAFT RENEWABLE SLEEVE AREA – If the shaft area between the renewable sleeve and the first flight is air cut to a depth no greater than 1/4 inch of the shaft diameter for a 1" area, or if a 1/4" deep band is cut around the shaft, the screw is repairable.
